Case Study: Charlotte, NC

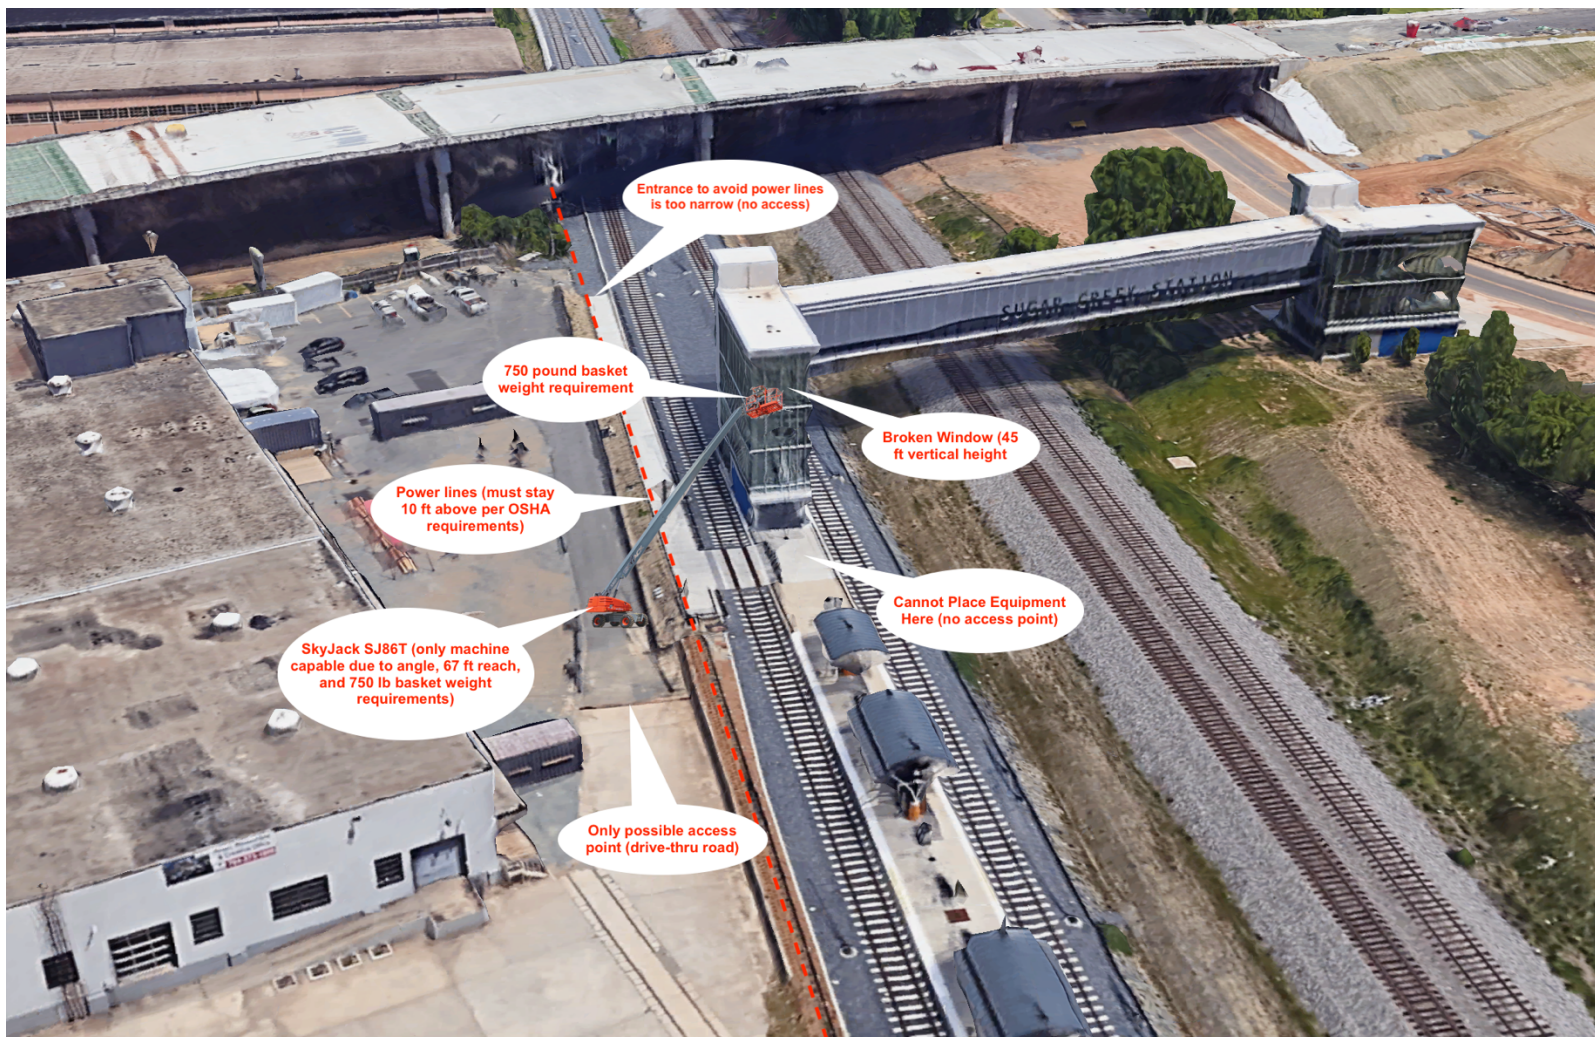
Aerial view of job site and scenarios:

The contractor determined there were two possible placement options for the equipment.

Contractor option one: Placing a scissor lift on the passenger platform area next to the building. The JED-EYE software determined that the entrance to the platform had width restrictions due to barricades resulting in no access or equipment recommendations.

Contractor option two: Placing a boom lift on a walkway ramp leading up to the passenger platform. The JED-EYE software determined this also had width restrictions at the entrance of the ramp resulting in no access or equipment recommendations.

JED-EYE recommendation: Placing a boom lift on a drive-through road, requiring the lift to reach up and over power lines. This option was previously ruled out by the contractor and sales representative due to power lines, reach, and angle requirements.

The final option was positioning a boom lift on the drive-through road, this was determined by the JED-EYE software as the only solution. The sales representative was able to recommend and order a Skyjack SJ86 T for the contractor as this was the only lift that met all parameters required; weight capacity, up and over height of the power lines (including the OSHA specified 10 feet of clearance) and the overall reach capability.
